Fireline

Sprinkler Obstruction Investigations

Microbiologically influenced corrosion is a major cause of sprinkler system obstructions. How can it be detected and controlled?

BY BRIAN SAUER

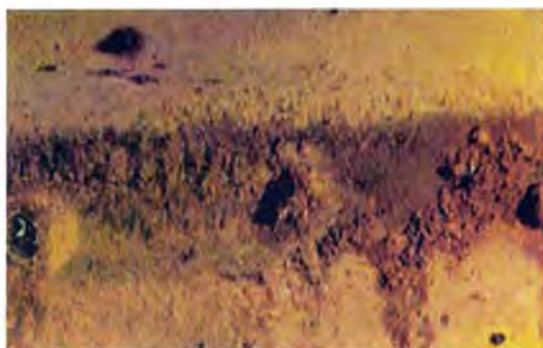
Photo 1: Pitting inside of piping. Photo provided by the American Fire Sprinkler Association

As MIC bacteria grow, consumption of the metal pipe occurs and can result in the formation of tubercles. During this process, pitting of the interior lining of the sprinkler pipe may occur. Regardless, the hydraulic characteristics of the sprinkler pipe are negatively impacted by the tubercles. Last, the tubercles and loose scale can cause sprinkler heads or valves to become blocked or to not function properly if pieces break free during a water flow event.

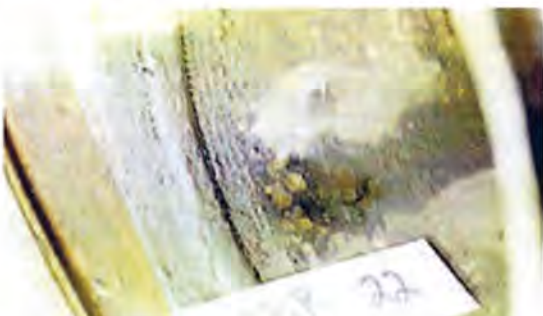
Photo 2: Pitting that remains after chemical cleaning of the pipe to remove tubercles. Photo provided by the American Fire Sprinkler Association.

•**Step 3.** Cleaning of the piping is required to remove the scale and debris and should only be undertaken by professionals according to a predetermined written plan. All surfaces should be cleaned down to bare metal. New technology has made it possible to chemically clean the piping in place. This should be done according to FM Global guidelines, including test samples of pipe and metallurgical examination following the cleaning. Any sprinkler heads removed for flushing of the system with the cleaning solutions should not be reinstalled but replaced with new heads after cleaning is complete.

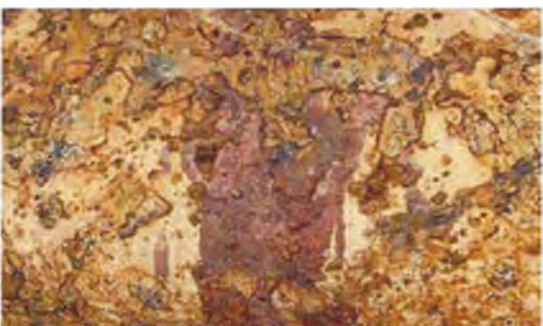
Photo 3: Microbiologically influenced corrosion. Photo provided by Potter Electric Signal Co.

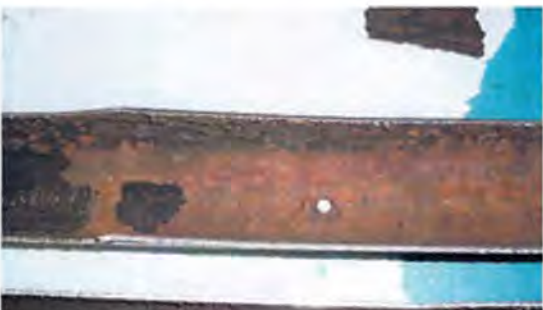
Photo 4: Internal pipe corrosion and hole in galvanized sprinkler piping. Photo provided by Potter Electric Signal Co.

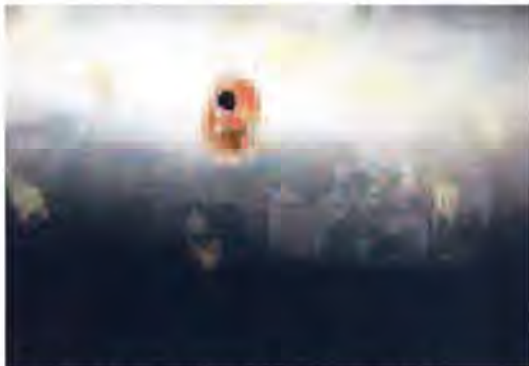
Photo 5: Hole created in sprinkler piping by MIC. Photo provided by Potter Electric Signal Co.

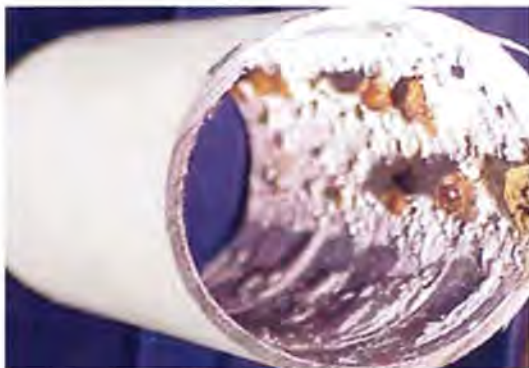
Photo 6: MIC tubercles inside of galvanized Schedule 40 sprinkler piping. Photo provided by Potter Electric Signal Co.

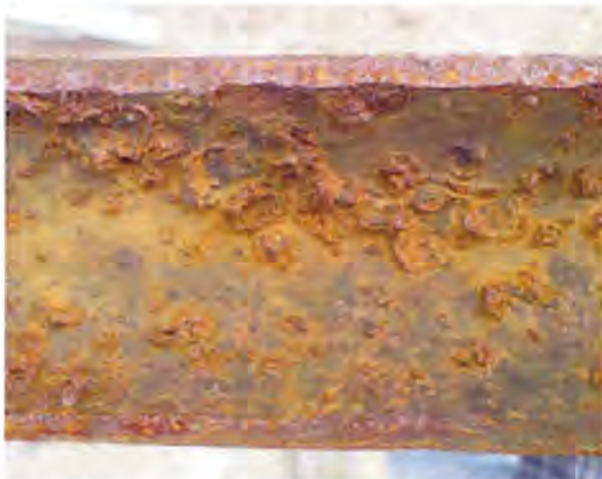
Photo 7: MIC tubercles (biodomes) inside of sprinkler piping. Photo provided by Potter Electric Signal Co.

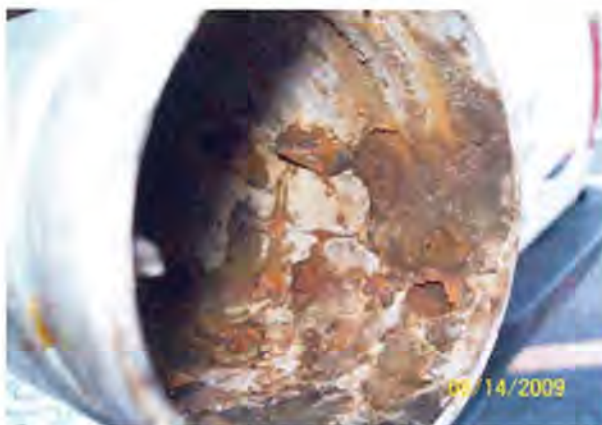
Photo 8: Scale that can form in dry pipe sprinkler systems that can break off and clog pendant-type sprinkler heads. Photo provided by U.S. Automatic Sprinkler Corp.
